A review of the experience of thaumasite sulfate attack by the UK Highways Agency

Neil Loudon

Highways Agency, SSR CE SDM Division, Heron House, 49-53 Goldington Road, Bedford MK40 3LL, UK

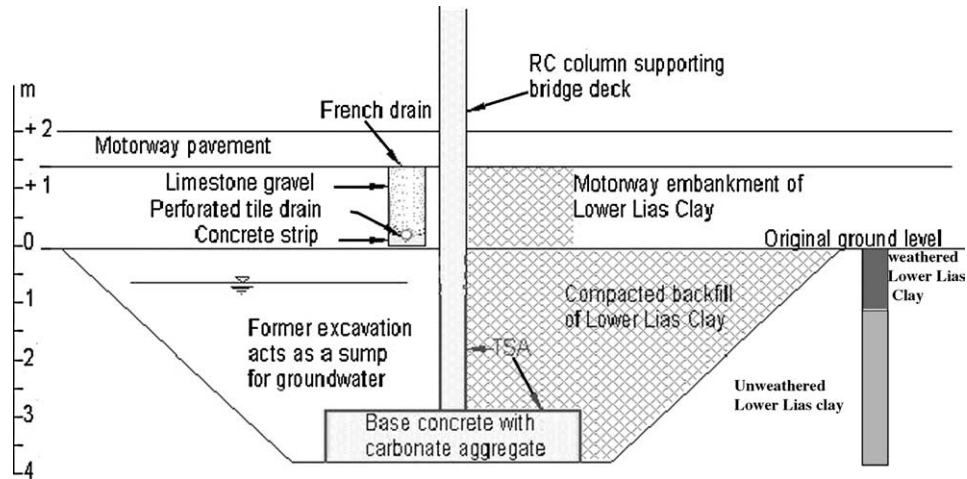
Fig. 1. Diagrammatic representation of Tredington-Ashchurch Overbridge.

Other papers at the conference will deal with the Tredington-Ashchurch case study in much more detail, however suffice to say that it transpired that a number of critical factors in combination had occurred (listed below), which were significant in terms of the deteriora-

tion that occurred, and particularly in relation to the severity of the thaumasite sulfate attack:

- (a) use of limestone aggregates in the concrete;
- (b) use of sulfate and sulfide bearing materials for backfilling around the foundations and buried columns (the soil excavated to construct the foundations contained iron pyrites (sulfides) which started to oxidise after exposure to the atmosphere, and added to the reservoir of available sulfates);
- (c) groundwater movements;
- (d) physical disposition of the structure (deep foundations and slender concrete elements);
- (e) construction regime, particularly the excavation of a large hole through undisturbed ground which was subsequently backfilled with the excavated materials and created a 'sump' around the buried columns;
- (f) leaking motorway drainage;
- (g) relatively cold conditions.

These factors are illustrated in Fig. 1.

Alongside the continuing site investigation work, records of the structure were inspected, and also available geotechnical information. It was evident that the design of 30 years ago had been undertaken in accordance with the standards and specifications of the time, based on the contemporary soil survey. This had duly taken account of the prevailing soil conditions in regard to the occurrence of sulfates. However at that time there was no requirement to consider sulfides, and so in comparison to the rules developed in 1999 in response to the discovery of thaumasite, may have underestimated the influence of sulfates by 2–3 classes (based on BRE Di-

gest 363 [1]). Clearly this was very significant, but no fault could be attached to the design or construction process of 30 years ago.

Based on the information available at the time, and the need to undertake the planned strengthening work on the columns against vehicular impact, it was decided that the columns should be removed. This decision was reached after considerable deliberation, and assessment of costed options, but was influenced by the lack of available information on how to repair structural elements affected by thaumasite. There was also uncertainty as to whether the concrete deterioration had 'stabilised' or was continuing. In the event the most effective strategy was the complete removal of the bridge columns. A system of temporary propping was introduced to allow the columns to be cut up and removed, and a new foundation and supports cast on top of the existing foundation.
